# 7. Mississippi River Gorge Landslides

## Landslides on near-vertical faces in the Mississippi River Gorge

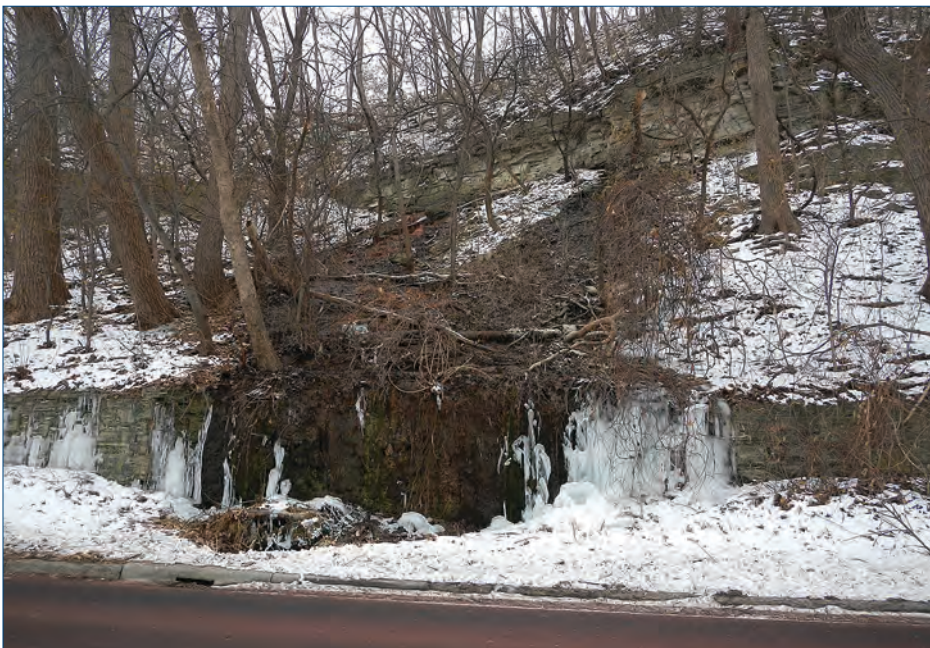
**Figure 7.5 — Springs and Seeps**

Springs and seeps have a bearing on landslide locations because they can create reentrants in the gorge wall by sapping (physically removing grains where they emerge) and enlarging fractures by dissolution, in some cases creating significant subsurface voids and sinkholes. Seeps are visible in winter by icy accumulations at distinct layers. Springs have a great enough flow rate that they do not freeze (Figure 7.5).

Immediately downriver from the Fairview Riverside Medical Center slide site, there is a combination of seeps (ice) and springs (wet, green and rusty) emerging from the Platteville Formation. Iron in the springs is oxidized when it emerges and the constant-temperature water supports mosses and other vegetation.

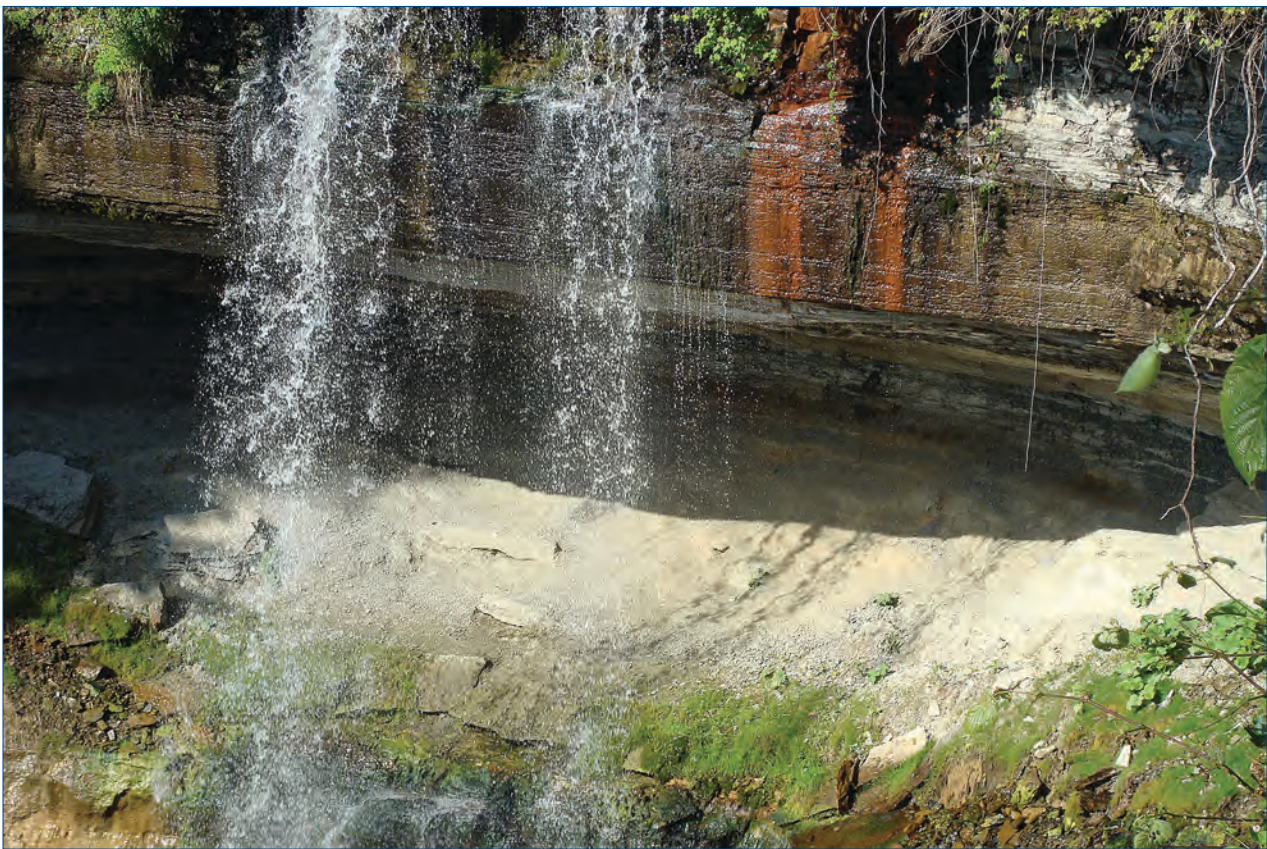
**Figure 7.6 — Overhanging Mifflin Member**

The primary style of bedrock failure involves block failure of a cantilevered or otherwise projecting slab of Platteville Limestone, typically the Mifflin Member. The underlying St. Peter Sandstone is more easily eroded and undercuts the limestone. This process is facilitated by springs and mechanical erosion. When the slab is ultimately destabilized and topples, it destabilizes the slope above it and can release significant amount of rock and loose glacial sediment. This is the main mechanism of retreat of tributary waterfalls and evidence for undercutting of the Platteville Formation is easily observed at Minnehaha Falls (Figure 7.6). Smaller blocks of the

At Minnehaha Falls, it is easy to see the reentrant in the slope that forms along the Glenwood Shale where springs emerge. This creates overhanging ledges of the Mifflin Member that break along joints. Fallen blocks can be seen on the slope (and in the pool below the waterfall, not shown here). Photo credit: Julia Steenberg, MGS.

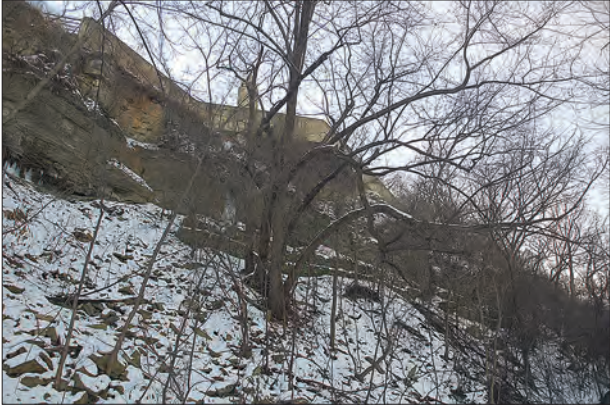
**Figure 7.7a — The Overlook at Fort Snelling History Center**

People gather on a cement platform that projects beyond the bluff face and is underlain by a vertical fracture in the Platteville with a seep.

The fall-zone along the slopes on the Hennepin County side of the gorge is primarily occupied by trails but also includes portions of roadways north of Franklin Avenue. Remediating portions of the slope with the most activity above them or below them is prudent as is removing reasons for people to linger in these zones (e.g., benches, signage, view points). For example, the overlook at Fort Snelling History Center projects beyond the bluff face and is underlain by a vertical fracture in the Platteville with a seep (Figures 7.7a and 7.7b). Encouraging people to stand here should be carefully evaluated.

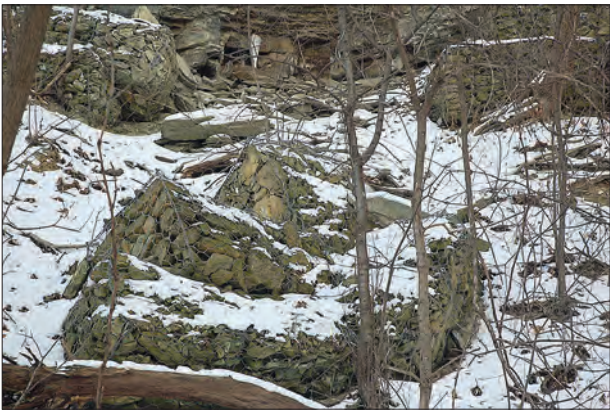
**Figure 7.7b — Repair and Failure Below the Fort Snelling Overlook**

The gabion wall baskets created below the overlook have begun to fail.

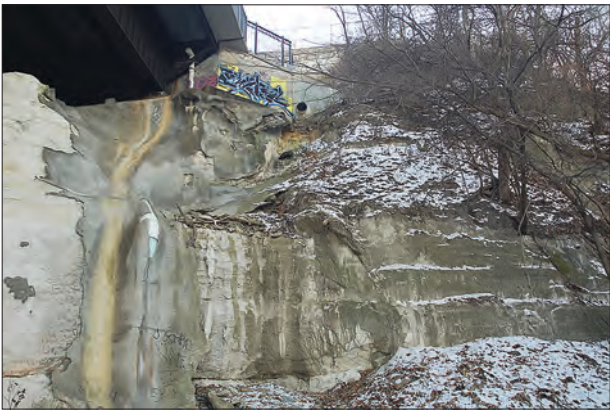
**Figure 7.8a — Erosion of St. Peter Sandstone Near Infrastructure**

Upriver side of Highway 5 Bridge abutment where repairs to the face of the St. Peter Sandstone have been made to protect it from undercutting.

Careful placement of stormwater infrastructure is important so as not to induce erosion, especially in the more easily eroded St. Peter Sandstone. For example, under the Highway 5 Bridge abutment (Figures 7.8a and 7.8b), erosion-control measures put in place have varying levels of permanence.

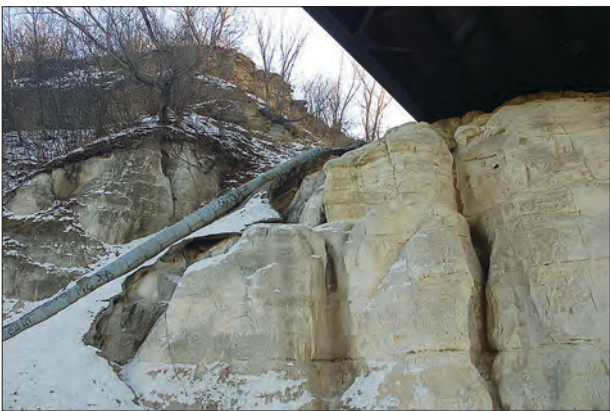
**Figure 7.8b — Erosion of St. Peter Sandstone Downstream Side of Highway 5 Bridge**

Downstream side of the Highway 5 Bridge abutment where repairs and a rerouted pipe were apparently put in place to protect the St. Peter Sandstone. Erosion is now occurring beneath the cement overlay.
