APPENDIX C

PEDESTRIAN AND BICYCLE ISSUES

To: John Slack, Stantec
From: Ciara Schlichting, AICP, Hannah Pritchard, PE and Tony Hull
Date: 5/30/2014
Re: Lowry Avenue NE Corridor – Key Pedestrian and Bicycle Issues

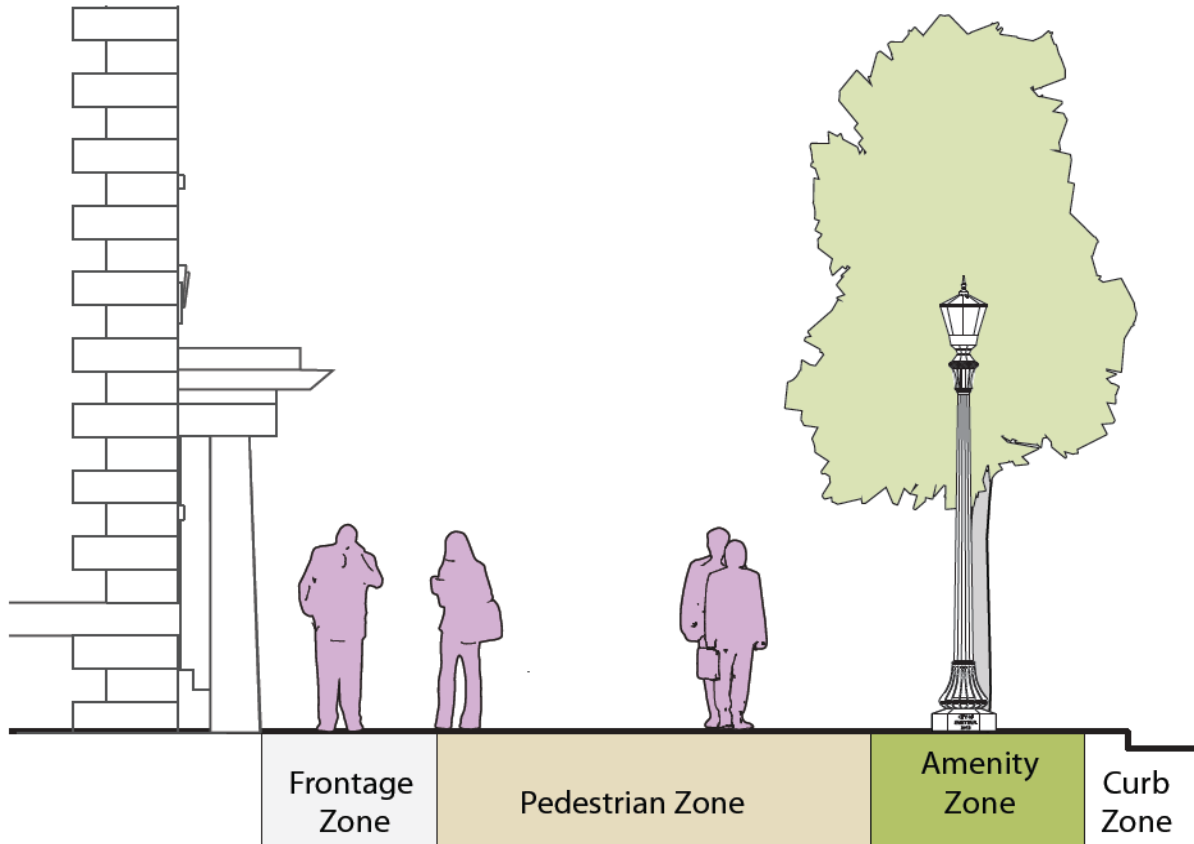
Figure 1. Sidewalk Zone System

The Sidewalk Zone System includes four zones: Frontage, Pedestrian, Amenity, and Curb – that vary in terms of width and character depending on the adjacent land use, available right-of-way, and intended function. The combined space of the Amenity and Curb Zones are sometimes referred to as the Buffer Zone, as these provide separation for pedestrians from the moving traffic in the roadway. The sidewalk zone system is shown on the following graphic and each zone is described in detail below.

Curb Zone - This is also called the transition zone (separating pedestrian zone from the vehicular travel way). The curb zone provides a physical barrier (curb) and also provides space for getting in and out of a parked car (where on-street parking exists).

Amenity Zone - This is where all the “stuff” goes (benches, newspaper boxes, utility poles, signs, street lights, trees, snow storage, etc.) This zone clearly defines a reasonable space for all of our “stuff”.

Pedestrian Zone - This is the operational element of the sidewalk and needs to be well defined and maintained at all times. This is also what is referred to as the Pedestrian Accessible Route (PAR), or the space that needs to meet ADA standards for egress along the travelled way.

Frontage Zone - A small buffer at the right of way line to account for the distance we naturally want to be away from walls, fences, doorways, etc. (i.e., 2 – 6 feet)

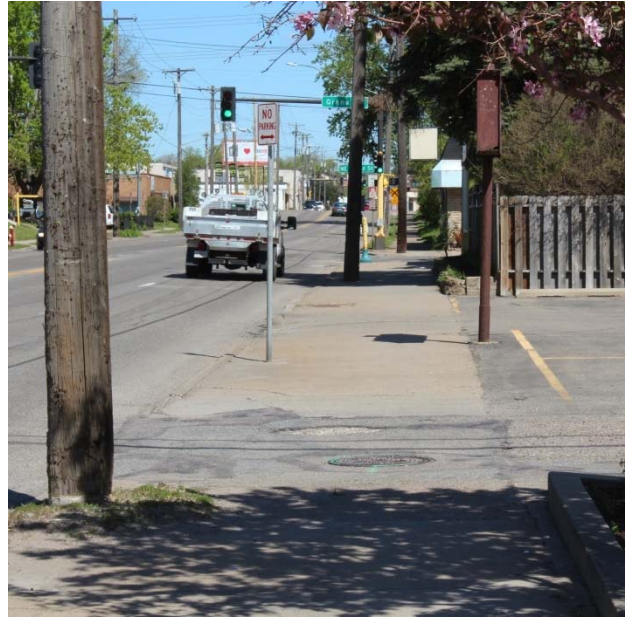
The sidewalks along Lowry Avenue NE are significantly constrained along the corridor. Intended sidewalk widths were measured to be between five and eight feet. At some major intersections, and in areas where buildings have been set back behind the right-of-way, the usable pedestrian space is as much as 13 feet. However, in other areas, the five-foot sidewalk area is being encroached upon by residential yards and landscaping that has not been maintained. Once space used for the amenity zone is taken into account, the passable pedestrian area is frequently three feet or less.

Figure 2. Examples of inconsistent sidewalk zone

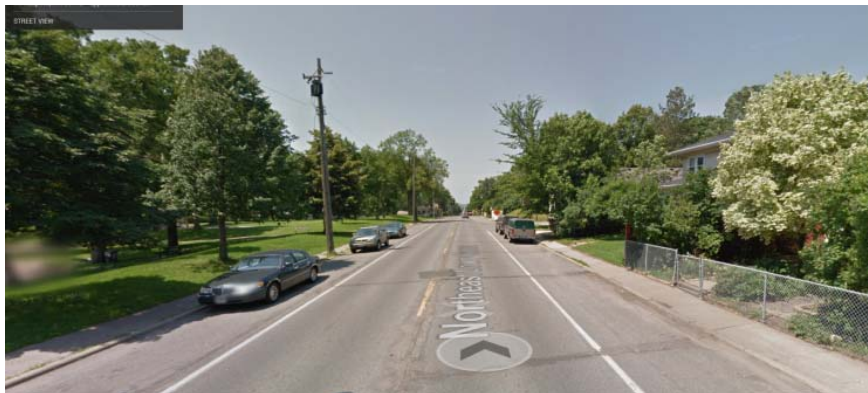
Figure 3. Example of Sidewalks with a Curb Zone Buffer (Striped Parking Bays East of Central Avenue)

The portion of Lowry Avenue NE east of Central Avenue includes striped parking bays that provide some buffer between pedestrians and travel lanes (i.e., the parked cars in the Curb Zone provide a buffer).

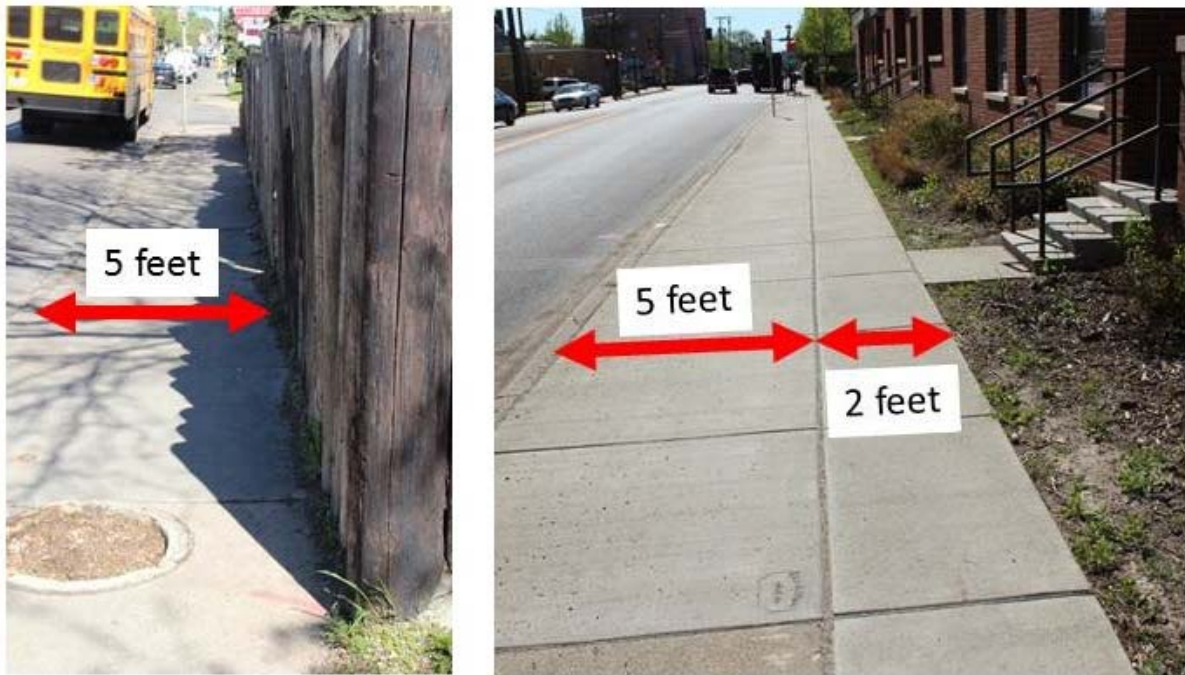
Inconsistent development set-backs. On residential lots with fences, the fence is built right to the property line, providing no additional pedestrian space. However, on commercial land uses, buildings may be set back one or two to provide additional room. Figure 4 illustrates a residential fence that increases the narrow feel of the sidewalk area, as well as a new development that has opted to increase the sidewalk width in addition to setting the building back from the edge of the right-of-way.

Figure 4. Examples of development set backs

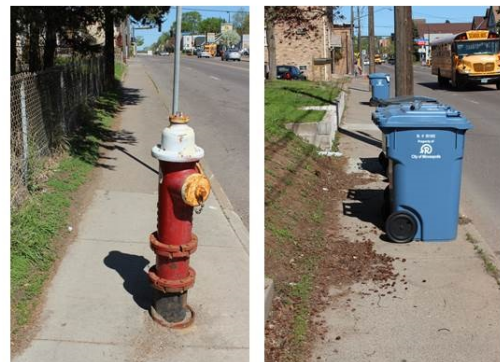
Sidewalk obstructions. Sidewalk obstructions are prevalent throughout the corridor and minimize the width of the pedestrian travel way. A minimum of 36 inches (3 feet) is required for Americans with Disabilities Act (ADA) compliance. Obstructions include sign posts, utility poles, vegetation, temporary signs, and garbage cans. Above ground utilities, furniture, and vegetation would otherwise be placed in the Amenity Zone if it were available. The space between the fire hydrant and the edge of the grass in Figure 5 was measured at two feet, 3 inches. A person in a wheelchair would be required to travel in the street to pass through this portion of the corridor.

Figure 5. Examples of Sidewalk Obstructions

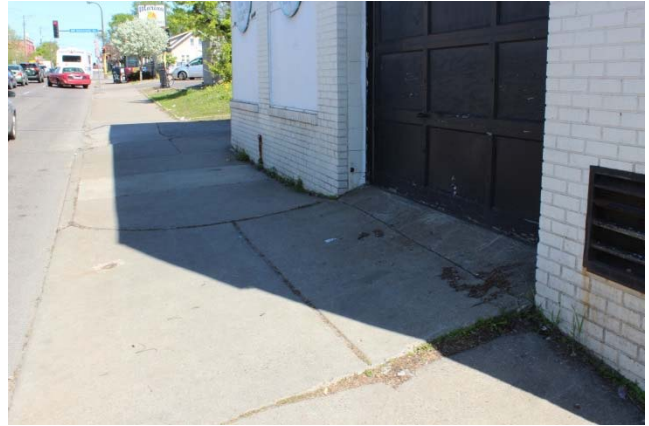
Driveway apron grades. Driveway apron cross slopes compromise the accessibility of the sidewalk. The narrow sidewalk space frequently results in a curb-adjacent sidewalk without a defined curb or amenity zone. Where driveways occur there is not adequate space to provide for the transition from roadway to driveway without interrupting the sidewalk. In many cases this results in sections of sidewalk where cross-slope exceeds the 2% needed for Americans with Disabilities Act (ADA) compliance (see Figure 6). Additionally when driveways are poorly defined or maintained, potential conflicts increase between vehicles and pedestrians where it is not clear where the driveways and sidewalks begin or end.

Figure 6. Driveway Apron Grades Limit Accessibility

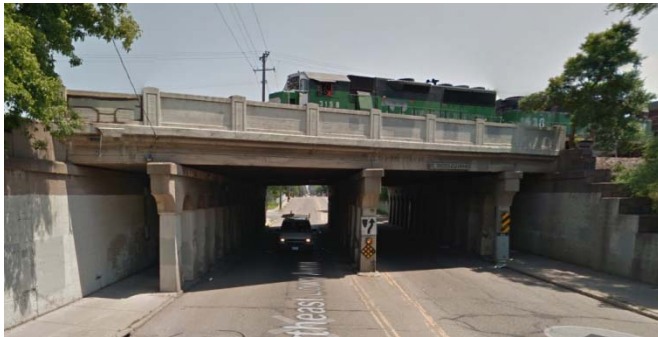
Figure 7. Railroad Viaduct Lacks Pedestrian Scale Lighting

viaduct provides a narrow pedestrian travel way that is not well lite and poses personal security concerns.

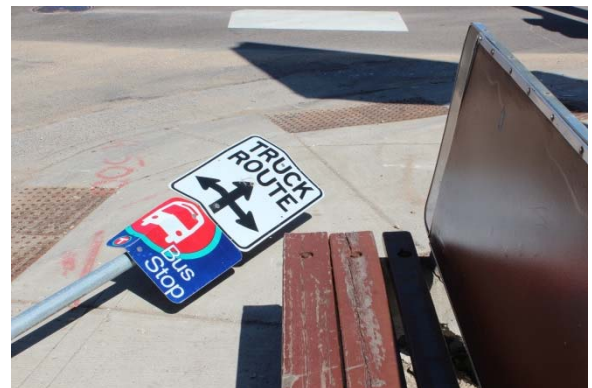
Truck movements. Lowry Avenue NE is a truck route, with significant truck movements going through the Lowry Avenue NE / University Avenue NE intersection. Trucks create more noise than passenger cars, which impacts pedestrian comfort along the corridor. In addition, there was visual evidence of large vehicles entering the pedestrian space when making a turn (Figure 8). This is an issue that has also been raised by project stakeholders.

Figure 8. Bus Stop sign Knocked Over by Turning Truck

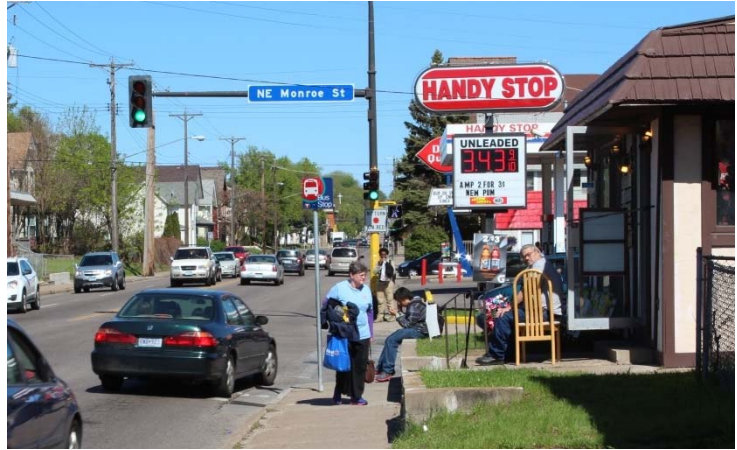
Transit stop design and service. Some bus stops lack benches, shelters, concrete pads and snow removal in the winter. In Figure 9, the retaining wall for the private business serves as a de facto transit waiting area. Bus frequency and lack of service during the evening and weekends limits the mobility of transit dependent populations. Where shelters or benches do exist, they frequently add to the obstructions in the walkway, further adding to the sidewalk clutter and confusion.

Figure 9. Bus Stop Lacks Shelter, Resting Area and Concrete Pad to the Curb

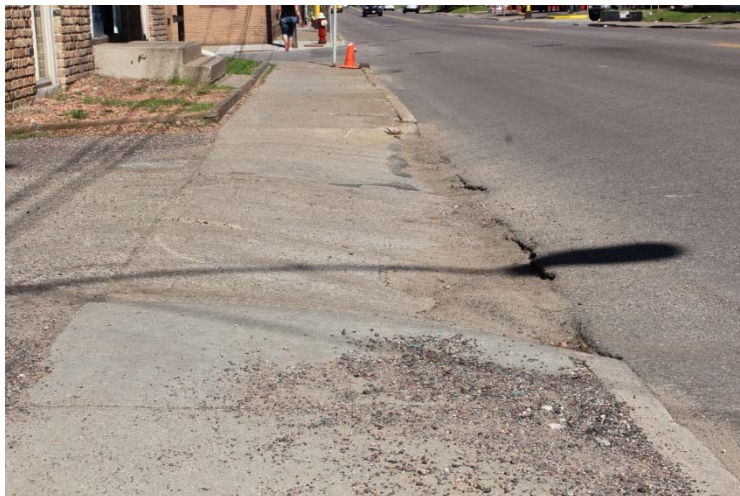
Deteriorated curb face. Curb conditions vary block by block and some are in poor condition and provide a compromised grade separation from the road bed to the sidewalk. In many sections the deteriorated curb provides little to no vertical separation from the roadway, facilitating encroachment on the sidewalk for maneuvering and/or stopping or parked vehicles, delivery trucks and buses.

Figure 40. Example of Deteriorated Curb Face

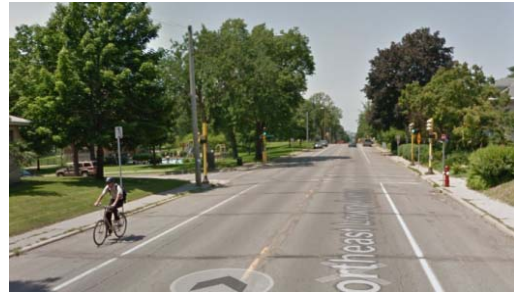
No marked or signed bicycle facilities. Lowry Ave NE provides a shared lane configuration for bicyclists without any markings or signs that remind users that bicycles are allowed to share lanes with motor vehicle traffic. Bicycle count data shows that Lowry Ave NE has a higher rate of sidewalk riding than other count locations (Figure 11), which indicates that bicyclists are not comfortable sharing the road with motorized vehicles.

Figure 5. Bicyclist Riding in the Parking Bay

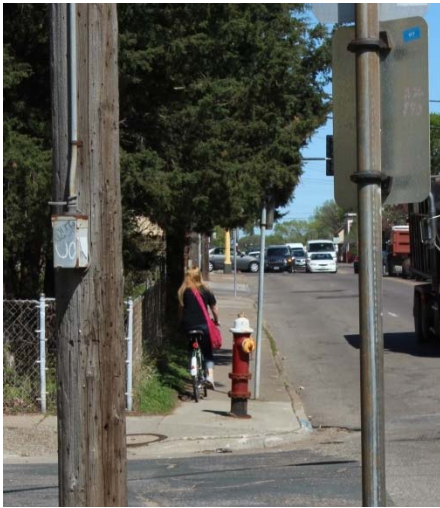
Figure 12. Bicyclist Riding on the Sidewalk
