# 7. Mississippi River Gorge Landslides

## Landslides on near-vertical faces in the Mississippi River Gorge

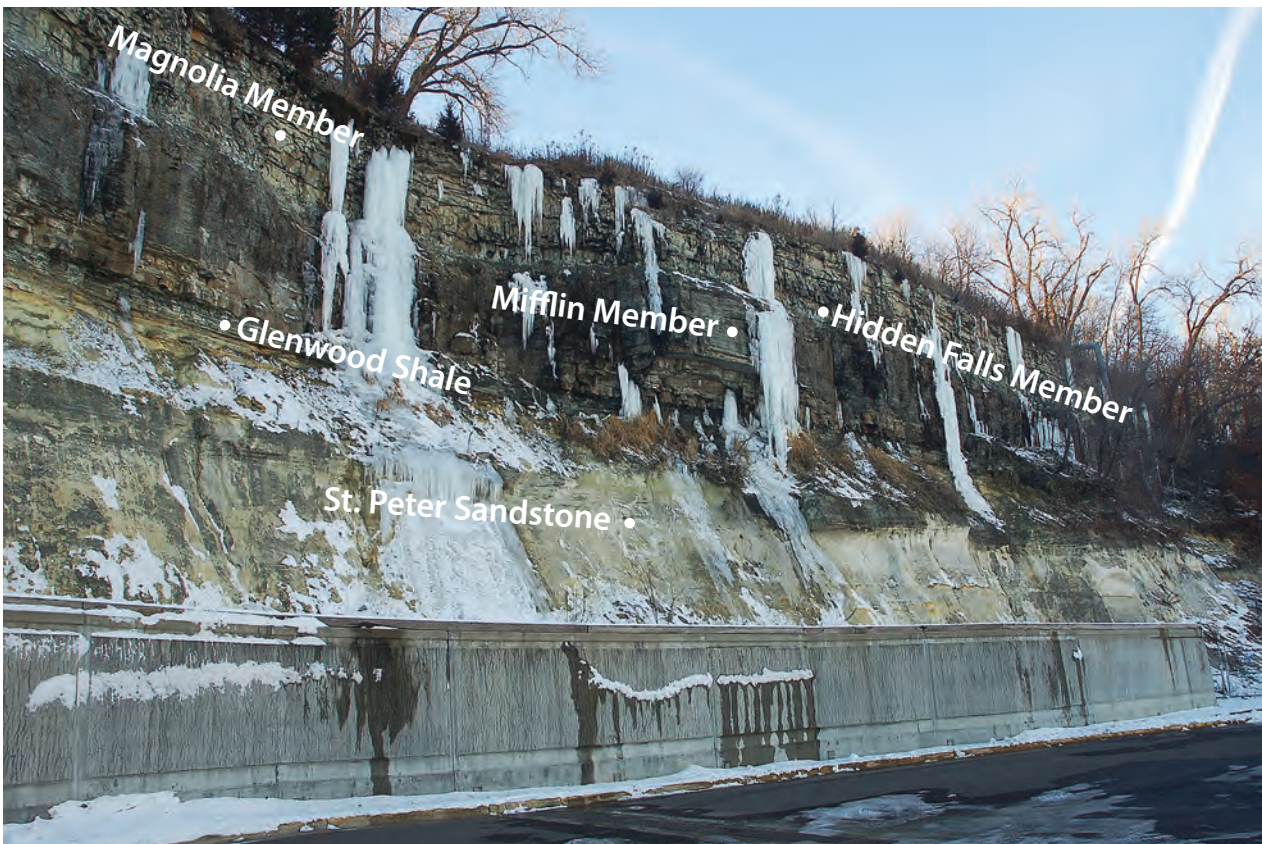
**Figure 7.3 — Bedrock Sequence** The Magnolia Member is 7–10' thick and has a blocky appearance. The Hidden Falls Member is 4–6' thick and has curvilinear fractures. The lowermost Mifflin Member is 11–13' thick and breaks off in large, tabular slabs. Springs emanate predominantly from Magnolia/Hidden Falls contact (48%) and Hidden Falls/ Mifflin contact (25%). Seeps along bedrock layers exposed above the Ford Dam can be identified by ice. (*Runkel et al., 2015*)
